## SPECIAL ISSUE ARTICLE

# Hillslope degradation in representative Italian areas: Just soil erosion risk or opportunity for development?

## Abstract

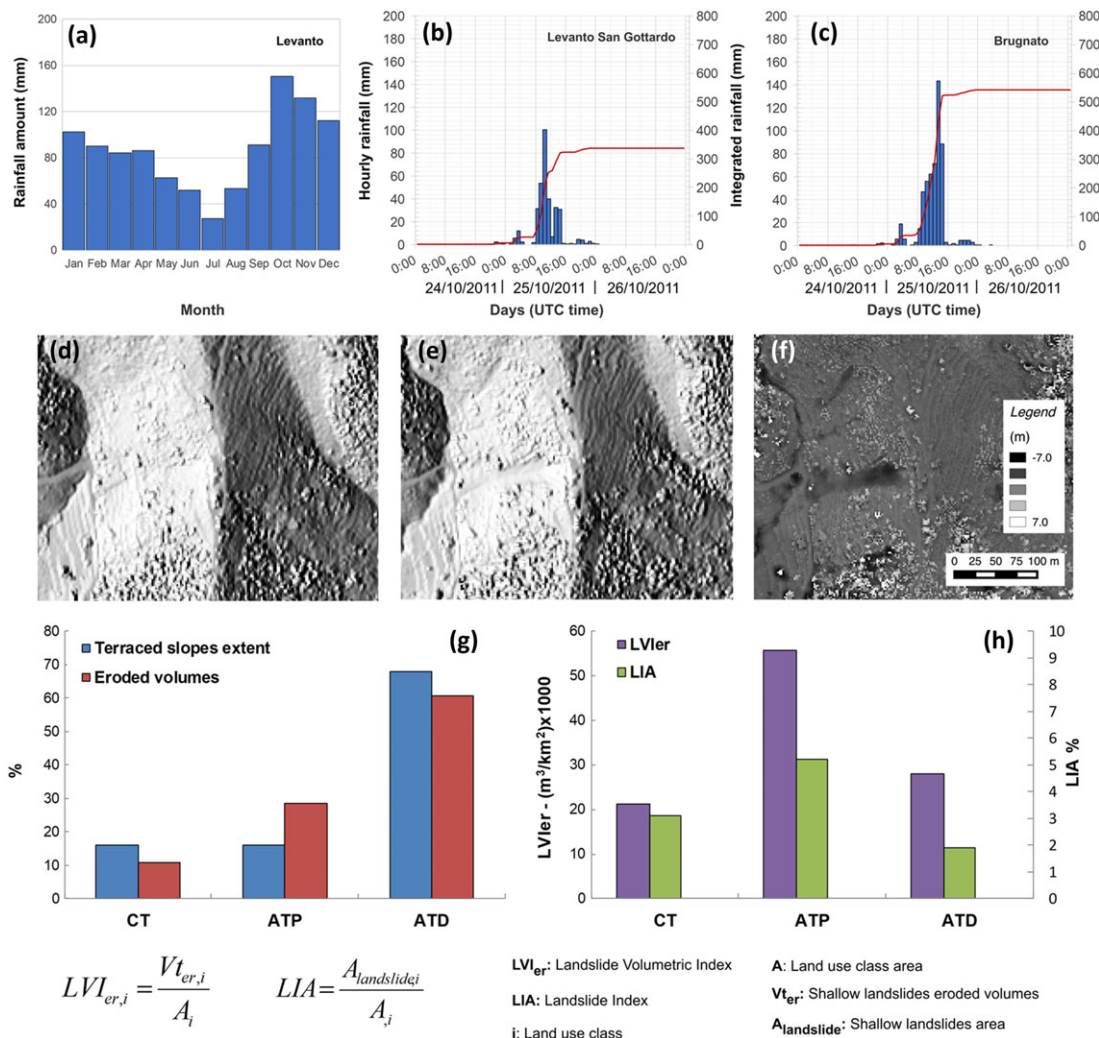
**FIGURE 2** Main climatic features of the Cinque Terre area (Liguria): mean monthly precipitation (1954–2016 period; a); representative hyetographs and cumulative rainfall plots (b, c) of the October 25, 2011, extreme rainfall event. Shallow landslide volumes evaluation: pre-event (d) and postevent (e) light detection and ranging-derived digital surface models; digital elevation model of differences (f; after Brandolini et al., 2018, modified). Shallow landslides volumes results: histograms reporting eroded volumes (g) and indices LV<sub>er</sub> and LIA (h) in relation to terraced slope conditions (CT, cultivated terraces; ATP, abandoned terraces with poor cover; ATD, abandoned terraces with dense cover; modified after Brandolini et al., 2018) [Colour figure can be viewed at [wileyonlinelibrary.com](http://wileyonlinelibrary.com)]

rainfall peaks slightly higher than 110 mm h<sup>-1</sup> (Figure 2b). Rainfall amounts were even more severe within the inland Vara/Magra valleys, where a cumulative daily rainfall value of 539 mm was recorded, with an hourly rainfall intensity of up to 153 mm h<sup>-1</sup> (Figure 2c; Cevasco et al., 2015). The mobilized materials from the slopes were charged by streams giving rise to mud/debris floods that affected the Vernazza village, causing considerable damage and three casualties. Immediately after the event, coupling detailed analysis of high-resolution aerial photograph with field surveys, an inventory of the geo-hydrological processes was performed (Cevasco, Brandolini, Scopesi, & Rellini, 2013). Within the Vernazza catchment, more than 500 rainfall-induced shallow landslides were mapped along with many intense accelerated erosion processes, corresponding to about 1.50% and 1.65% of the entire basin area, respectively. The analyses of the landslide distribution in relation to land use revealed that landslides particularly affected agricultural terraced slopes pointing out their extreme vulnerability. In fact, approximately 88% of the landslides were triggered on terraced environment (Cevasco et al., 2014). In this regard,

pre-event and postevent LiDAR digital terrain model comparison (Figure 2d) revealed that shallow landslide mobilized soil volumes were higher for abandoned terraced slopes than for still cultivated ones (Brandolini et al., 2018). Furthermore, important findings came from the relationships between landslide magnitude and degree of abandonment. Brandolini et al. (2018) evaluated the mobilized debris volumes per unit area, by means of the definition of the landslide volumetric index, revealing that ATP represented the most hazardous land use class since being characterized by erosion rates resulting approximately two and three times higher than that of ATD and CT, respectively (Figure 2e, f). These results confirm that land abandonment and agricultural mismanagement can play a key role in intensifying the magnitude of shallow landslides in case of a single extreme rainfall. Because of the high environmental and cultural values of the area, the restoration of abandoned terraces along with the recovery and maintenance of drainage systems must have a primary role in the future scheduling of mitigation and prevention strategies of geomorphological risk (Brandolini & Cevasco, 2015).

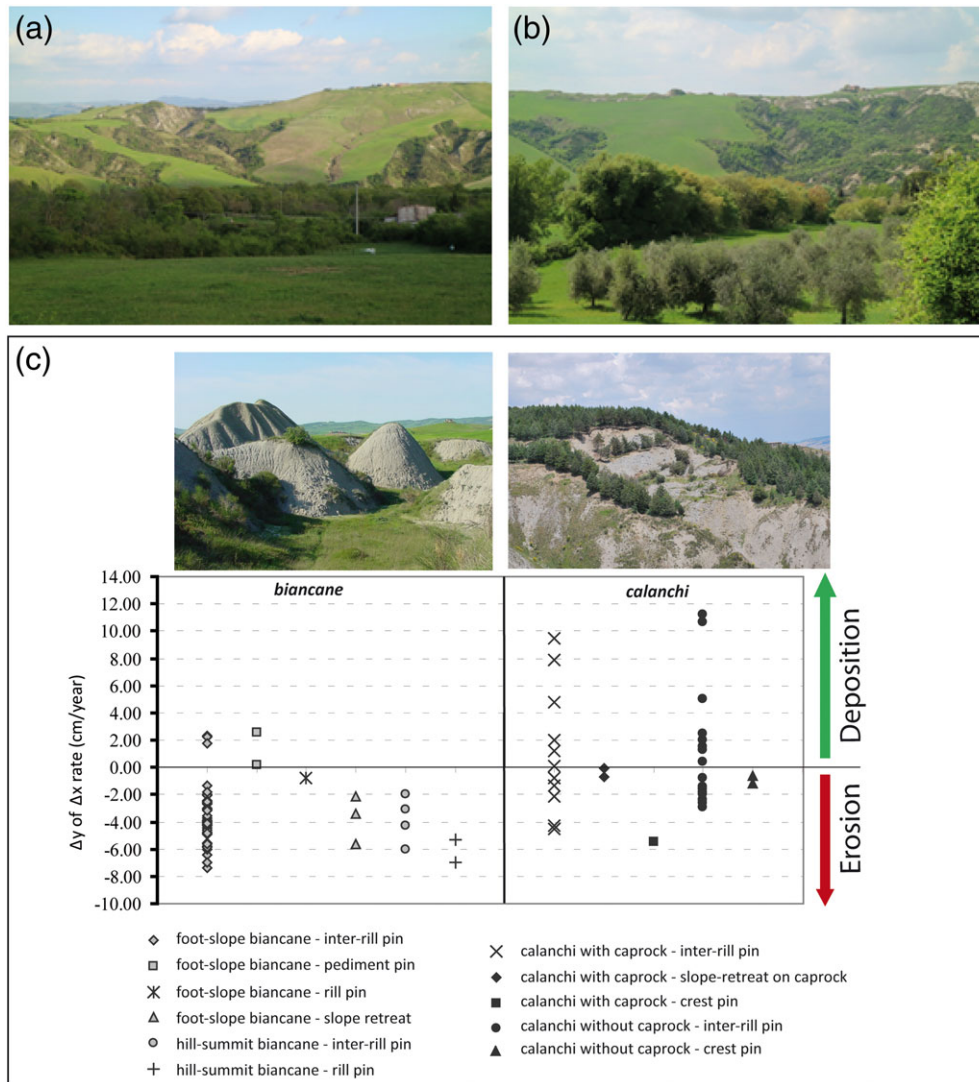
**FIGURE 5** (a) *Calanchi* badlands levelled for land reclamation. (b) *Biancane* badlands (on the right) survive next to an area (on the left) remodelled to enlarge cropland surfaces. (c) Summary of the mean erosion rates recorded at all *calanchi* and *biancane* sites during long-lasting geomorphological studies in Tyrrhenian side of central Italy (after Vergari, 2015); both vertical ( $\Delta y$ ) and horizontal ( $\Delta x$ ) variations of ground level were recorded at different sites and positions on slopes [Colour figure can be viewed at [wileyonlinelibrary.com](http://wileyonlinelibrary.com)]

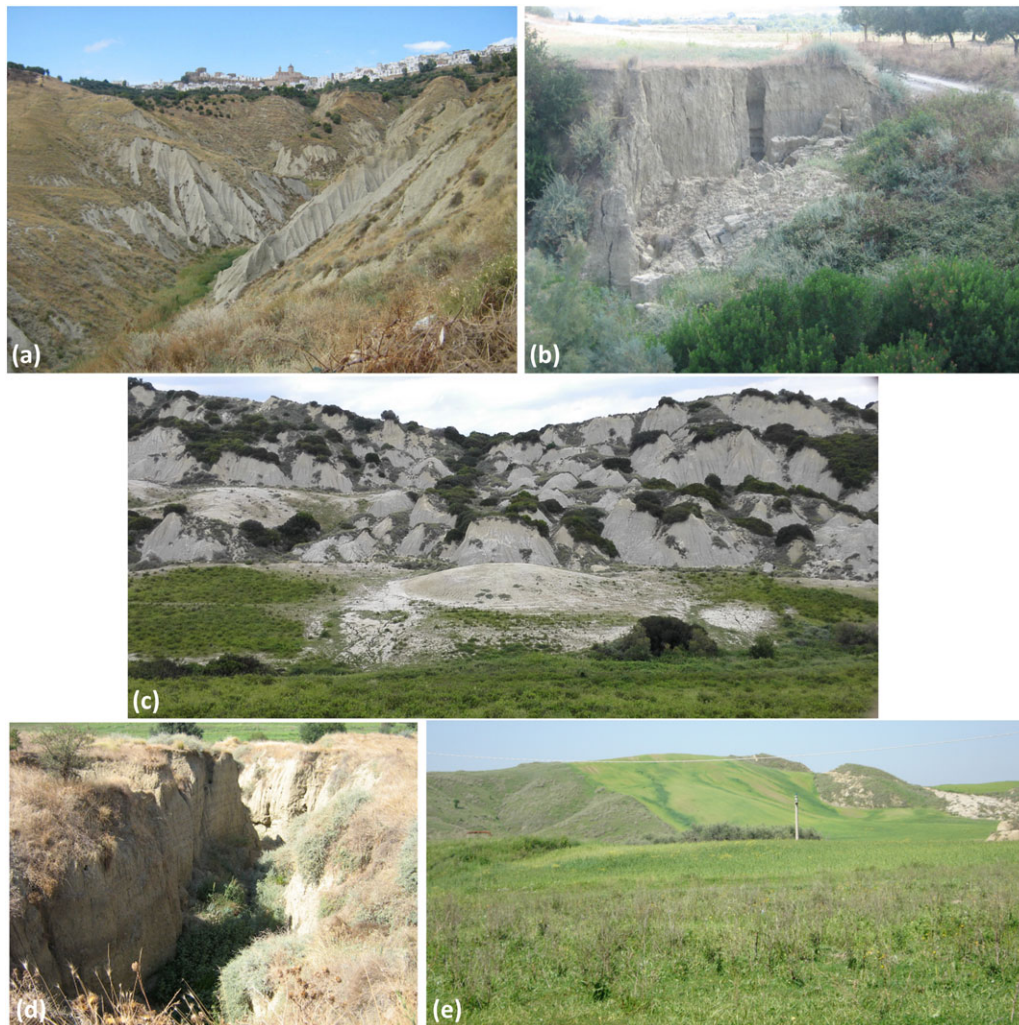
**FIGURE 7** Some features of the Basilicata land degradation areas: (a) *calanchi* beneath the town of Pisticci; (b) landsliding of the gully walls due to piping (see the big pipe in the middle of the wall); (c) *biancane* landscape near the Aliano town, in foreground a remodelled area and new forming rills; (d) deep gully in the Basento floodplain; (e) remodelled slope where superimposed rills are highlighted by difference in humidity and vegetation [Colour figure can be viewed at [wileyonlinelibrary.com](http://wileyonlinelibrary.com)]

In this area, there are three types of land-degraded zones especially in terms of accelerated soil erosion: *calanchi* areas, *biancane* areas, and gullies in valley fills. The *calanchi* areas develop on high energy relief and large degraded landscapes (Alexander, 1982). These areas present parallel close-packed gullies with vertically elongated grooves, and narrow and sharp ridges with steep, naked walls that are quickly incised and eroded headwards (Figure 7a, c). *Biancane* areas are low energy relief degraded land, generally shaped on slopes highly incised by rills, gullies, and collapsed pipes. They are dome-shaped forms (Figure 7c) enclosed by a micropediment (Torri & Bryan, 1997), and they develop when the erosion of a network of slightly inclined pipes is achieved. Many domes remain isolated from the slope as the pipe roof collapse (Piccarreta, et al., 2006). Gullies form in valley fills; they have vertical sidewalls, and they are about 10–30 m deep and 25–450 m wide (Figure 7d), due to the heavy lateral erosion (Piccarreta, Capolongo, & Miccoli, 2012; Piccarreta, et al., 2006). The headward gully erosion starts often from the collapse of tunnels and pipes (Figure 7b).

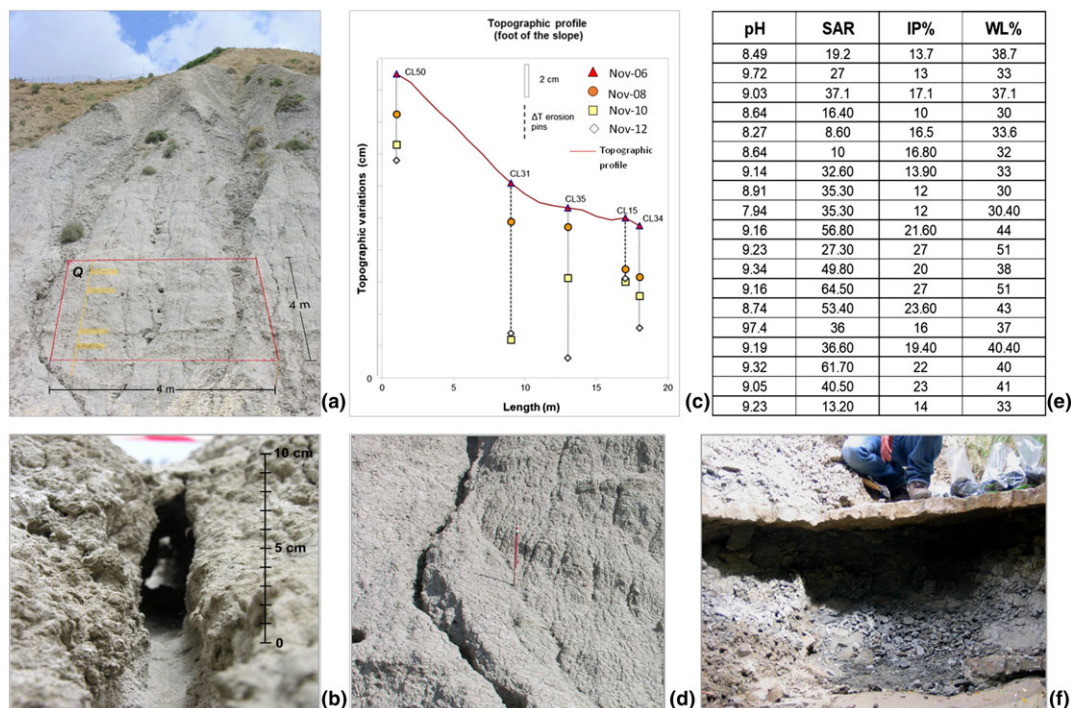
**FIGURE 9** (a) An example of survey cell to measure the density of pipes. (b) A small pipe. (c) Examples of relative height variations of erosion pins. (d) Erosion pins and drainage line on an old pipe after the fall of the top. (e) Some geochemical and physical parameters: pH, sodium adsorption ratio (SAR), plasticity index (IP), and liquidity index (WL). (f) Sampling and arenitic level [Colour figure can be viewed at [wileyonlinelibrary.com](http://wileyonlinelibrary.com)]

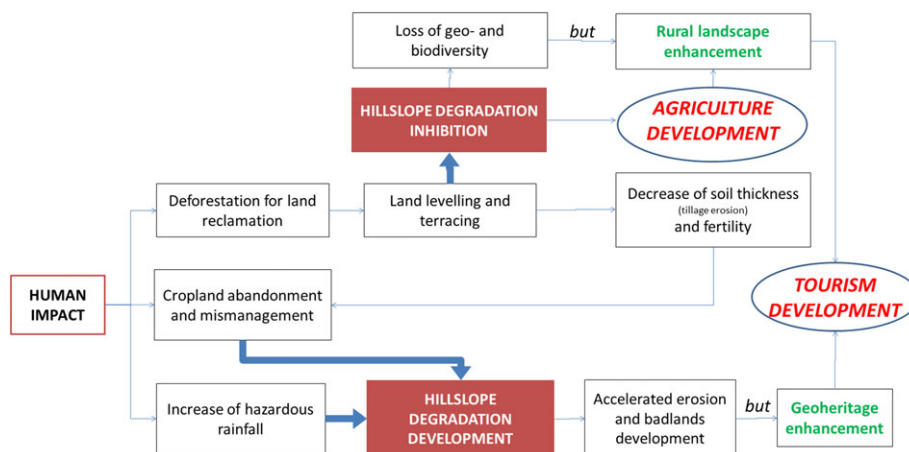
**FIGURE 10** Flow chart diagram summarizing the key aspects of hillslope degradation in the study areas [Colour figure can be viewed at [wileyonlinelibrary.com](http://wileyonlinelibrary.com)]

implications only (Figure 10). Indeed, this is also confirmed by the Val d'Orcia study case, where man has a dual role in land degradation. Although human impact involves soil loss and degradation due to intense agriculture and land mismanagement, it is also true that it has significant importance in the genesis of spectacular erosion landforms and landscape diversity (Bollati, Vergari, Del Monte, & Pelfini, 2016; Del Monte, 2017). Those characteristics attract many tourists, being an important resource for the economic development of the area. Dealing with the first issue (human as factor of land degradation), the effects of land levelling for land reclamation have been investigated by different authors, especially for the Crete Senesi landscape of Southern Tuscany badland sites (Amici et al., 2017), where this process is very widespread and it is also a consequence of the land reforms of the 1950s and, during the last decade, of the European Common Agricultural Policy. Deforestation, grazing, and farming significantly affect the frequency and extension of denudational processes, being among the most important triggers for accelerated water erosion, tillage erosion, and gravitational movements on slopes. The reworking of the clay material reduces the bedrock bulk density and changes its infiltration properties, causing an intensification of rill and gully erosion but also of piping (Marignani, Rocchini, Torri, Chiarucci, & Maccherini, 2008). In fact, despite the considerations made by Phillips (1998), who pointed out a reduction in clay dispersivity of the upper soil layers following reclamation as a critical factor in increasing soil stability, many studies on badland dynamics in the Mediterranean area (e.g., Lopez-Bermudez & Romero-Diaz, 1989; Calvo-Cases & Harvey, 1996; Calzolari, Torri, Del Sette, Maccherini, & Bryan, 1997; Torri, Regüés, Pellegrini, & Bazzoffi, 1999; Torri, Borselli, Calzolari, Yañez, & Salvador Sanchis, 2002; Torri et al., 2006; Borselli et al., 2006; Desir & Marín, 2007; Faulkner, Alexander, & Zukowskyj, 2008; Nadal-Romero & Regüés, 2010; Cappadonia et al., 2011; Pulice et al., 2012; Vergari, Della Seta, Del Monte, Fredi, & Lupia Palmieri, 2013; Vergari, 2015) confirmed that accelerated erosion in those areas is even enhanced by agricultural manipulation. Land abandonment without any land management strategy causes a further piping increase (Vergari, Della Seta, Del Monte, Fredi, & Lupia Palmieri, 2013), due to increased erodibility of the soil; and the great loss of material from the surface might cause the

As depicted in the flow chart of Figure 10, hillslope degradation also derives from the combined actions of humans and climate change condition. As occurred in Basilicata, land degradation and soil erosion features have been shown to be linked with specific land use changes, encouraged by agricultural policy, and with changes in precipitation regime. In Basilicata, the risk of land degradation is due to several factors, such as the seasonality of rainfall events according to the different agricultural practice (e.g., planting; Piccarreta, et al., 2006). The recent changes in rainfall regime, which show an increase of the dry periods and a tendency of a great magnitude of rain to concentrate into macroevents of three to four consecutive wet days, seem to lead to an increase of the erosion processes (Capolongo et al., 2008; Piccarreta et al., 2013). The clayey nature of the soils promotes the erosion, particularly because of land remodelling processes. These degradation processes are also due to the wrong application of specific policies that allowed the cultivation of bushy lands and badlands with durum wheat. Nevertheless, most of this land is progressively abandoned and is subject to erosion processes (Bentivenga, Capolongo, Palladino, & Piccarreta, 2015). However, studies on land use change data showed that the land degradation decreased since 1995. This trend is mainly due to the augmentation in sown areas, even if the reforestation policy, started after the 1950s, contributed to improving the quality of the land. This reduction is also due to the widespread badland remodelling for the durum wheat cultivation mainly along valley bottoms and river terraces. The resulting landscape has fewer erosive forms (Piccarreta, Capolongo, Miccoli, & Bentivenga, 2012). More recently, especially in badland dominated areas, large regional parks have been created. Those areas are exploited from both the environmental and cultural points of view where natural and historical initiatives coexist (Ciaranfi et al., 2012). In fact, the Regional Park of Calanchi of Montalbano Jonico (set up with a Regional Law of 2011) and the Literary Park of Carlo Levi at Aliano (declared since 1998) were established to enhance the badland landscape. This results in benefits to local communities in terms of income and jobs in the tourism sector, thus expanding the local economic opportunities. Agricultural practices represented important influencing factors of land degradation also in the Scillato Basin, the southernmost study area,

The comparison of the four study cases has aided in delineating the main anthropic and climatic influences in land degradation dynamics (Figure 10). If land degradation in all the considered areas has been historically initiated and favoured by deforestation for land reclamation, the hillslope denudation trend of the last decades can be credited both to the land use changes and mismanagement and to the increase of intense rainfall. The latter has proved to be the main triggering driver causing increased soil erosion in the Basilicata badlands, although it can poorly explain the erosion trends highlighted for the Upper Orcia Valley, where the trend on the erosion rates of the last decades, deduced by volumetric estimation after photogrammetric analysis (Aucelli et al., 2016), cannot be easily correlated to the variations on rainfall regime (Giaccone, Vergari, Del Monte, & Fratianni, 2015). The increase in high-intensity rainfall events is also relevant in the Cinque Terre area, where the last extreme events have determined hillslope instability issues (Brunetti et al., 2018; Cevasco et al., 2015), concentrating landsliding where land mismanagement predominates (Brandolini et al., 2018; Brandolini, Canepa, Faccini, Robbiano, & Terranova, 2007; Cevasco et al., 2014; Cevasco, Pepe, D'Amato Avanzi, & Giannecchini, 2017). In Sicily as well, agricultural practices come up to be a contributing factor for enhanced soil erosion. Therefore, as a matter of fact, in all cases, human-induced land degradation is pervasive. On the other hand, both the spectacular erosion landforms (e.g., *calanchi* and *biancane*) and the rural landscapes (e.g., terraced slopes and cultivated hilly territories) that characterize
