# Methodology for the Study of the Vulnerability of Historic Buildings: The Reconstruction of the Transformation Phases of the Church of the Abbey-Castle of Santo Stefano in Monopoli in Puglia (Italy)

**Abstract:** The study presented here concerns an analysis of the structural vulnerability of the arm of the church of the Castello di Santo Stefano Abbey in Monopoli in Puglia (Italy). The ancient monument is located on a small “Peninsula” between two ancient natural harbors, 3 km from Monopoli and 5 km from the archaeological site of Egnazia. Studies on the abbey-castle, have revealed different construction and deconstruction phases relating to historical periods of the Roman age, late antique age, medieval age, modern and contemporary age. The castle is typically attributable to a closed courtyard with four arms. The last one, close to the wall on the port of Tramontana, was added at a contemporary time. The arm of the church is characterized by the crypt with opus reticulatum walls from the two surviving bays of the former Benedictine church, from the residential palace of the 18th century, and from the residential extensions of the 20th century. The north-east and north-west ar

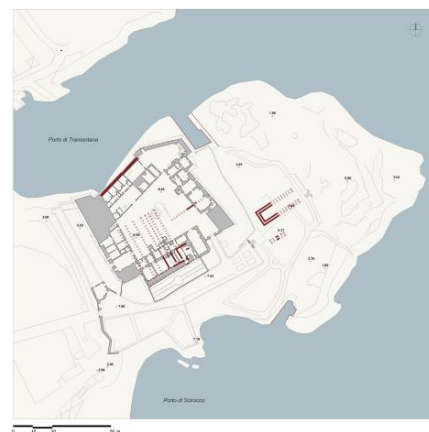
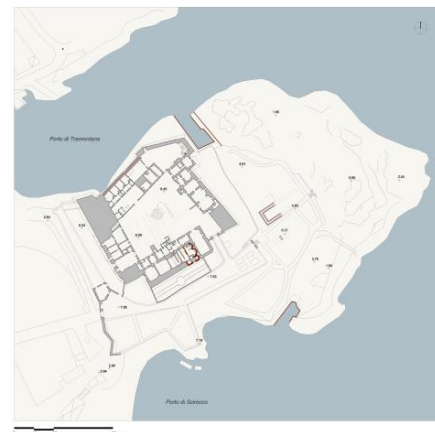
**Figure 2.** Reconstruction of the construction phases: Roman (a); and Late antiquity (b).

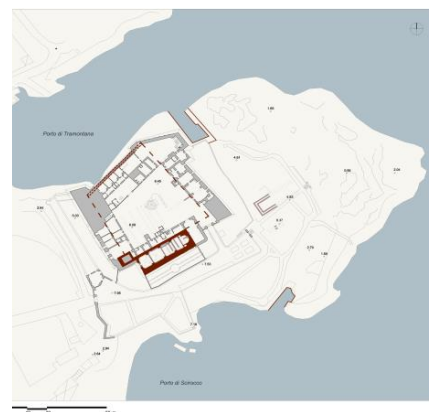
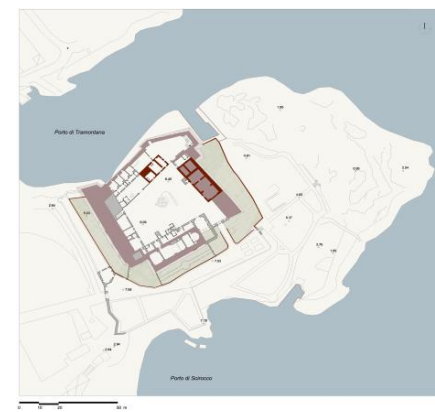
**Figure 3.** Reconstruction of the construction phases, Medieval (a); and 17th century (b).

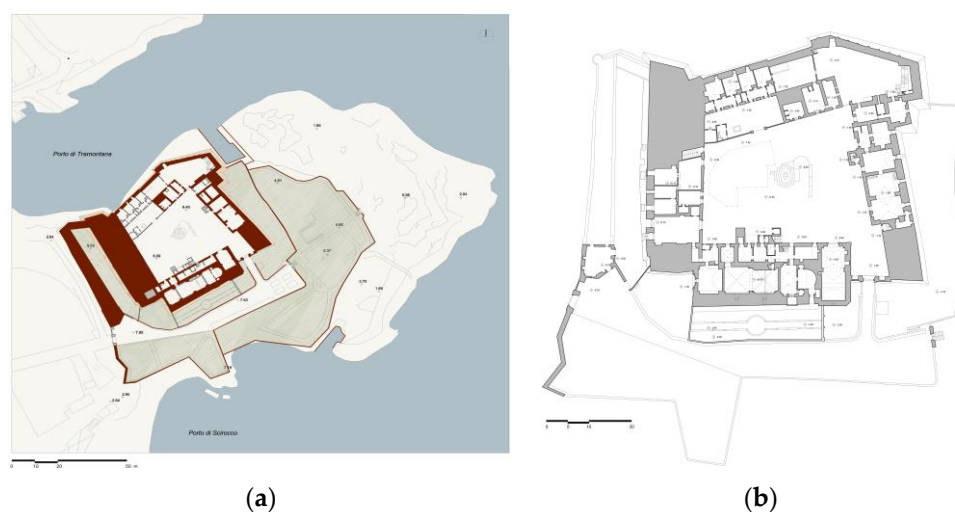
**Figure 4.** Reconstruction of the 18th century construction phase (a); Castle today (b).

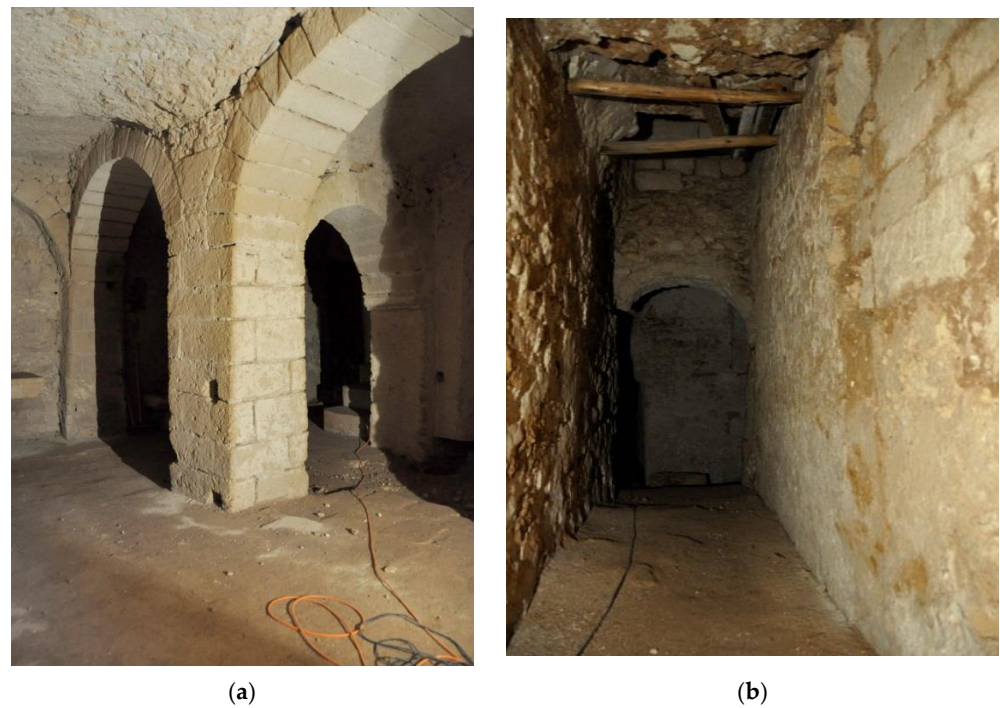
**Figure 7.** (a) View of the aisles; (b) View of the corridor.

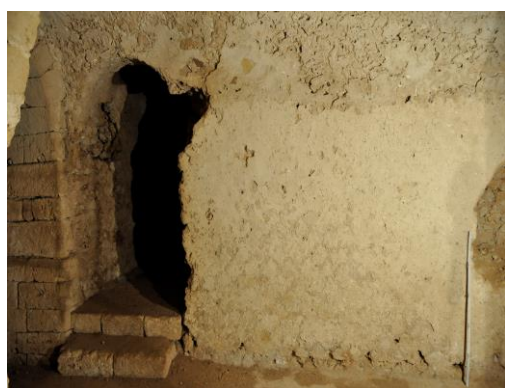
**Figure 10.** (a) Entrance of the corridor in wall BB'; (b) Thickness of wall BB' in opus reticulatum with morphological characteristics.

Inspection of the first wall section of the corridor brought to light the core of wall BB' of the crypt. The wall has a thickness of 60 cm with  $10 \times 10$  cm cubilia arranged on both rows and a core with shapeless stones, sea pebbles, marine sand and cocchiopesto (Figure 10). The opus reticulatum is very degraded. A state of alveolization is observed. Overall, the state of conservation of the crypt premises is compromised by various factors. The first cause of deterioration of masonry in opus reticulatum is attributable to rising damp. In fact, both in the crypt and in rooms (b) the opus reticulatum masonry rests directly on the rocky bank of the peninsula. In the rooms of the crypt the walls are covered with several layers of gray plaster (with great effort we have reconstructed the texture of the walls). In rooms (b) the side walls, in opus reticulatum, have no plaster and show the cubilia deformed by the crystallization of the salts. The cocchiopesto joints have almost completely disappeared. Another cause of deterioration that could have caused instability even in the upper rooms is the type of construction material of the opus reticulatum. A soft “tuffaceous” calcarenite predisposed to absorb salt, recovered in neighboring quarries already compromised by the saltiness.

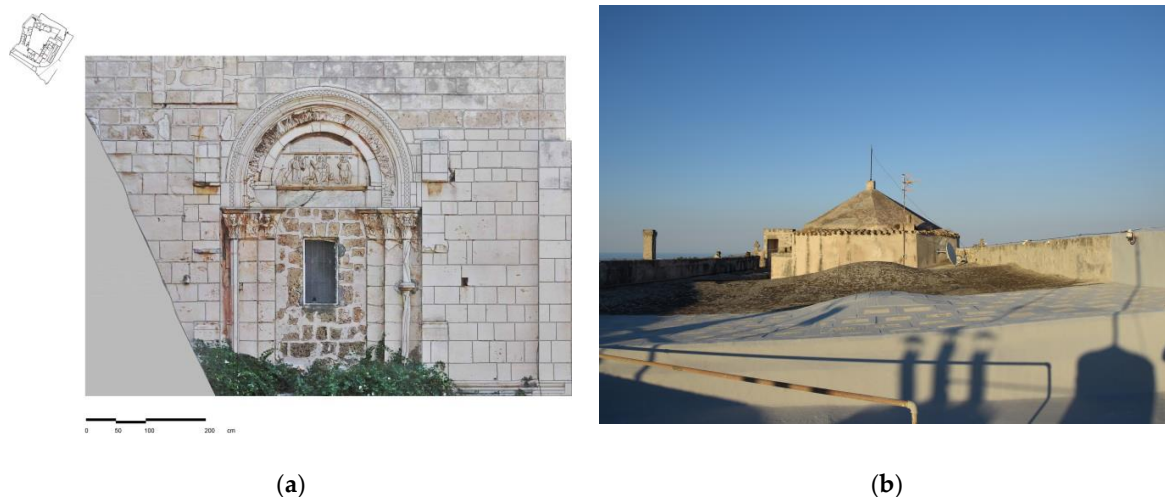
**Figure 14.** (a) Relief of the Benedictine portal; (b) View of the dome.

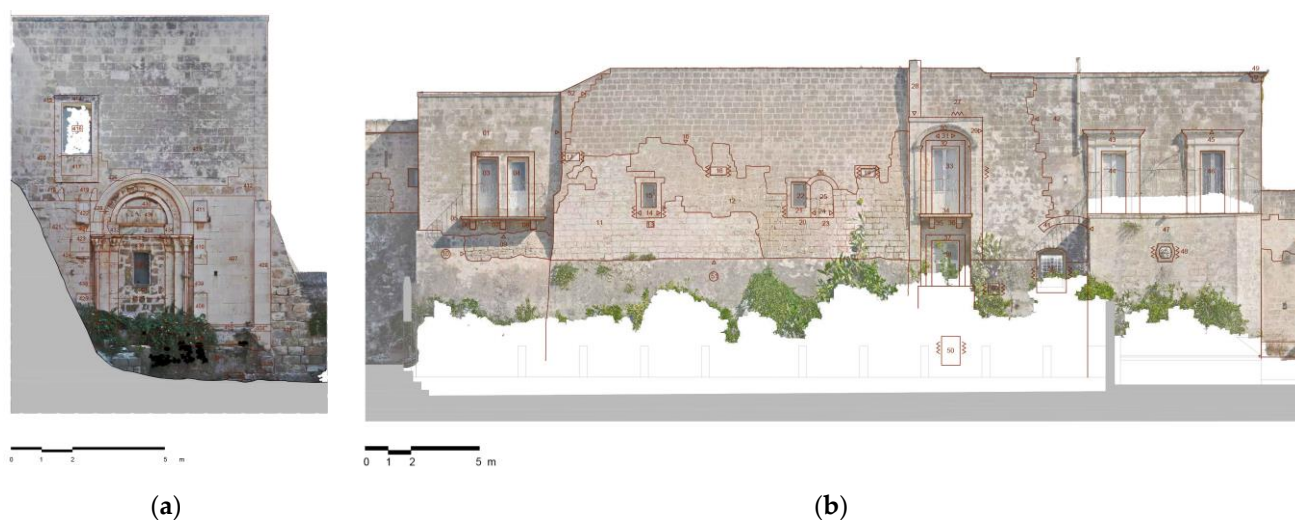
**Figure 19.** Stratigraphic analysis of the façade: (a) Western façade; (b) Southern façade.

The stratigraphic survey of the south facade has brought to light three distinct sections of masonry. The first, coming from the former first span of the church (houses on both levels) has a gabled back wall surmounted by a balcony. The wall structure is similar to that of the previous fourth span. The latter is characterized by a window with frames surmounted by a balcony with a mixtilinear profile (residential areas which include the apse choir), and finally the 19th-century loggia (of the new rooms). The central part of the wall, on the other hand, has ashlar of different sizes in the lower part (similar to those found on the ancient Porta della Tramontana) covered with a thin layer of plaster. In the interface area of the upper equipment, the key heads of three different chains can be seen. The upper ashlars, with concrete joints, are not comparable to those of the first two bays of the church or to the lower ones of the wall. The western facade, affected by the repositioning of the Benedictine portal, has an upper wall texture similar to the southern ones of the two former bays of the church (Figure 19).

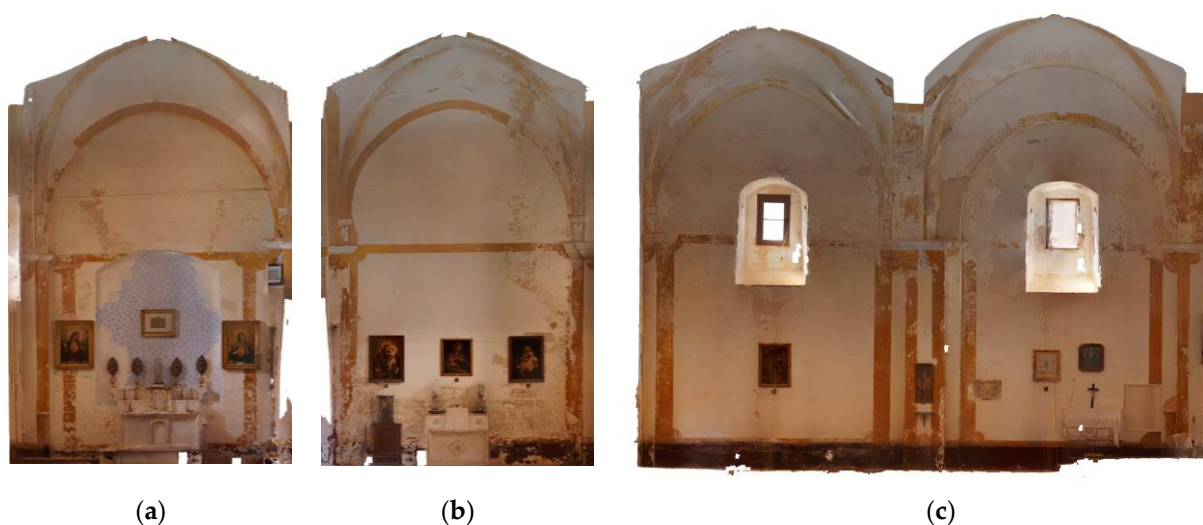
**Figure 20.** 3D relief: (a) altar; (b) back wall; (c) southern perspective section.

The inside the church, divided by six pillars, four of which are partially incorporated in the 19th-century partitions, has an uneven spatial hierarchy. The tax planes and pitch of the roofs are characterized by a morphological and constructive irregularity of the roof plane where the differences between the two roofs are highlighted. The vaulted ceilings are reconstructed. This intervention is also confirmed by the repositioning of the ribs of the crosspieces where a non-relationship emerges between them and the original sculptures, reinserted in a non-homogeneous way on the tax planes. Thermography of the window of the altar span shows the infill of half a lancet window—also evident on the external wall but compensated by the repositioning of the ashlar (Figures 17c and 18c). The single lancet window had to be positioned in the central point of the wall corresponding to the wheelbase, as in fact the window reconstructed in the 19th century is positioned. Therefore, the punctiform and vertical structures appear to have been “moved” as documented by the investigations of the spans. As proof of the above, the 3D survey of the internal section of the church shows the support pillar with the discharge of the new roofs offset with respect to its center of gravity [20] (Figures 20 and 21).
