Sedimentological features of asbestos cement fragments in coastal environments (Taranto, Southern Italy)

S. Lisco *, I. Lapietra, R. Laviano, G. Mastronuzzi, T. Fracchiolla, M. Moretti

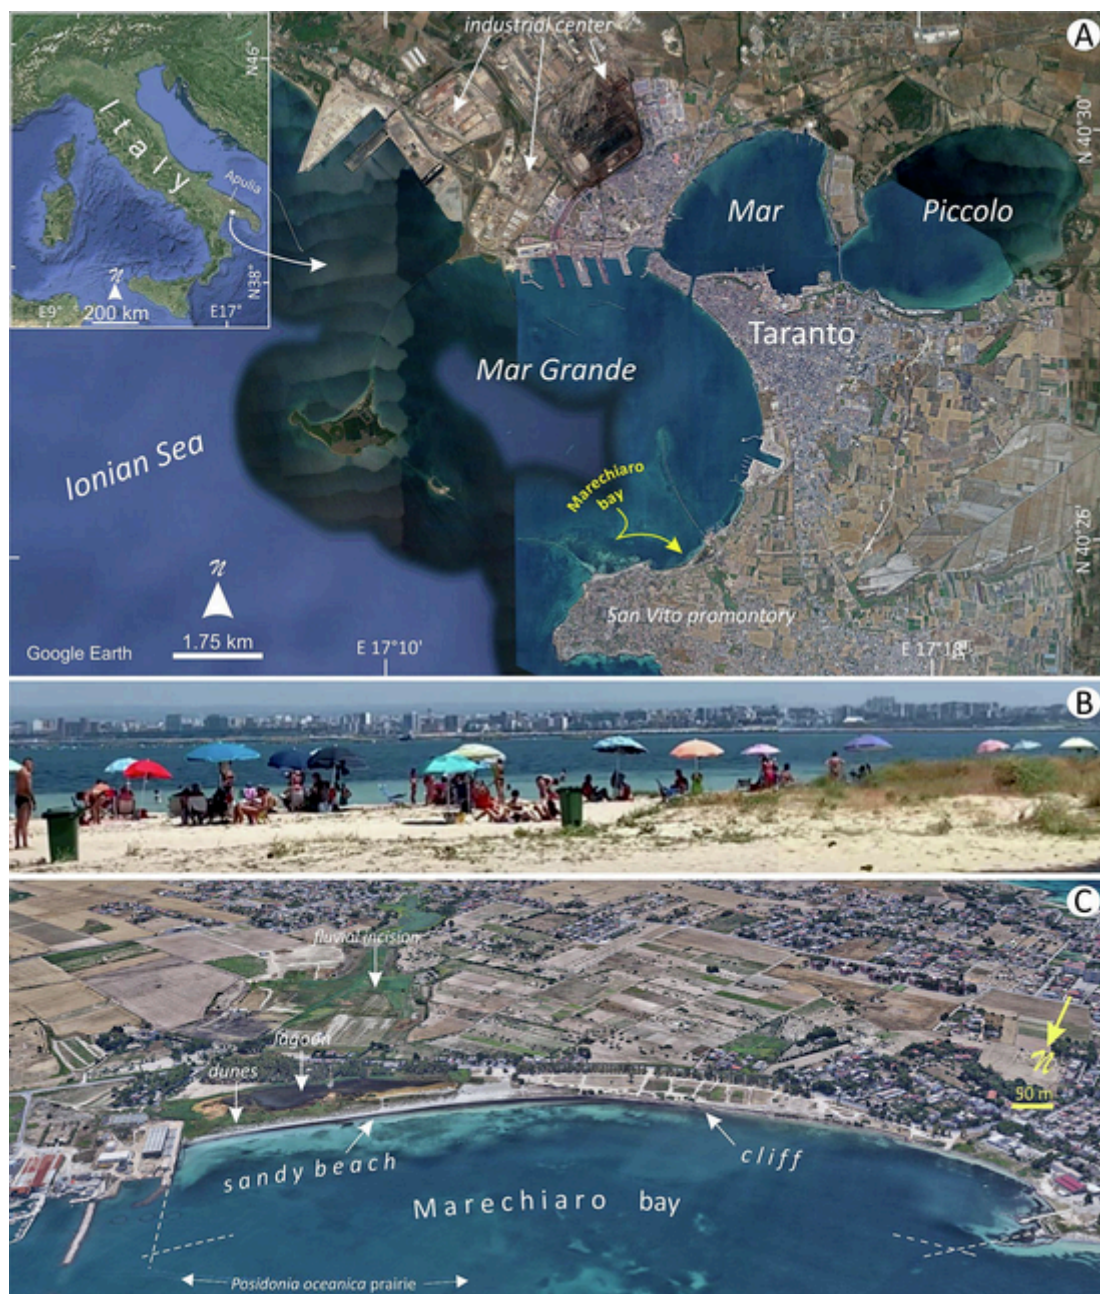
Fig. 1. A. The study area (Marechiaro bay) is located in the southern Mar Grande basin (northern Ionian Sea). Taranto city is limited by an extensive industrial center (North direction) which is directly connected with the Mar Grande and the Mar Piccolo marine basins (Google Earth 2022). B. Marechiaro beach is a traditional destination for the citizens of Taranto during summer season (photo taken on June 2020). C. The study area includes many environments with a significant naturalistic value (Google Earth 2022).

The city of Taranto, known as “the City of the Two Seas,” is located on the Ionian Sea between the Mar Piccolo and Mar Grande marine basins (Fig. 1). The coastal area of Taranto is one of the most polluted sectors of the European Union. The industrial center (Fig. 1) is responsible for the production of about 92 % of the Italian dioxin (9 % of all European dioxin). The results of epidemiological studies conducted on the local population show a dramatic mortality excess, and an abnormal increase in congenital malformations in children which seem to be connected to all forms of industrial pollution (Zona et al., 2019). For these reasons, the Taranto area has been included in the list of Sites of National Interest (SIN - Law 426/1998 and Ministerial Decree of 10/01/2000, 1998). For the purposes of their remediation, the SIN is identifiable based on the quantity and hazard of the pollutants present, the im-

The San Vito promontory (Fig. 1), located between the Mar Grande basin and the Ionian Sea, represents the closest and traditional marine recreational area, in part because of the location far away from the Taranto Industrial and urban centers. In particular, Marechiaro bay (literally, “clear sea”), along the northern sector of San Vito area, has numerous pocket beaches that characterize the promontory (Fig. 1). The study-area beach is between two rocky headlands made up of Quaternary carbonates (MIS 5 calcarenite deposits – Lisco et al., 2016;

Valenzano et al., 2018). Two submerged piers (a large submerged pier to the East and a smaller emerged one) were placed off of these bounding headlands (Figs. 1C and 2).

Marechiaro bay shows various physical elements and an unexpected biodiversity. The offshore transition sectors are covered by a large and dense *Posidonia oceanica* prairie (seagrass – Fig. 1C) which hosts many different benthic taxa (Rissoidea molluscs; and among the foraminifera: *Rosalina globularis* and *Cibicides lobatulus*) and the last individuals of *Pinna nobilis*, recently subjected to mass mortality processes in the Mediterranean Sea (Tiscar et al., 2022). The small dunes (Fig. 1C) are covered by robust and stable graminaceous herbs. In the retro-dune sector, a shallow lagoon (Fig. 1C) with abundant reeds and aquatic plants (and a population of migratory birds) exists. A narrow, N-S oriented fluvial incision has been obliterated by agricultural activities. This feature preserves the geological and biological characteristics of the so-called “Lame” which are the typical Apulian fluvial incisions with sub-vertical flanks and flat bottoms (Pieri, 1980).

The cliff of Marechiaro bay extends for about 500 m in length (Fig. 1C and 2) and has a sub-vertical shape (Fig. 3). It reaches a maximum of 3 m height in its central sector (Fig. 3A). The carbonate rocky substrate shows an irregular top which locally crops out at the sea level. A laterally continuous sedimentary body made up of the mixed man-made and natural debris occurs at the base of the cliff (OS in Fig. 3B). Debris deposits show a regularly sloped upper surface which extends from the cliff to the foreshore (OS in Fig. 3B); this regular top is frequently re-

The scuba diving survey shows that the seagrass begins below 5–6 m of water depth (the local base level of storm waves) and covers the offshore transition and deeper environments (Figs. 1C, 2 and 7A). The soft substrate is made up of fine-grained mixed sands with an abundant bioclastic content. The lower shoreface is nearly flat and contains fine-grained sands (Fig. 7A). This shoreface slope (upper shoreface) increases slightly as a result of the progressive increase in grain size toward the shoreline. The survey of the emerged beach sector shows gravel and coarse-grained sand along the foreshore covered by a thick

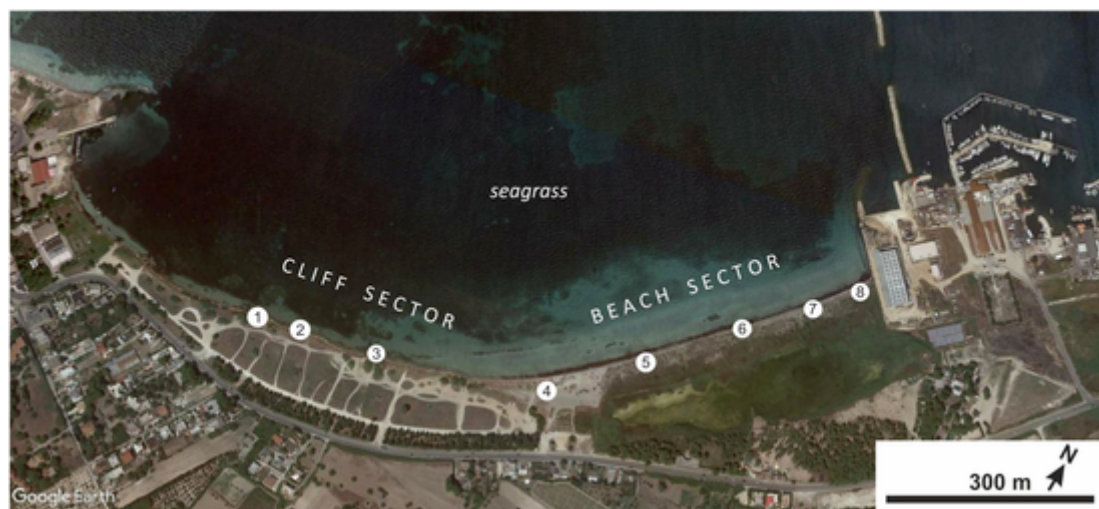
Fig. 2. Location of the stratigraphic sections described and/or sampled along the cliff (1, 2 and 3) and unit areas for ACM fragments counting in the backshore sector (4, 5, 6, 7 and 8). Samples of ACM for x-ray and SEM analysis were collected on the cliff (1), at the base of the cliff (2) and in the backshore area (4, 6 and 8). Google Earth 2020.

A detailed description of the stratigraphic succession, made up of dumped materials that crop out along the cliff, was carried out for three different points (sites 1, 2 and 3 – Fig. 2), a few tens of meters away from each other. Remains of commercial products were collected to approximate dates of the single stratigraphic dumping events. Five sampling sectors with a 4 m² area (points 4–8 in Fig. 2) were selected along the backshore (eastern sector of the study area), at the same distance from the coastline (about 2 m). The ACM fragments contained in the unit areas were photographed on site by using a white background and a graphic scale (80 ACM fragments with a minimum diameter of 0.02 m). High-resolution photos were selected to perform the morphometric analyses through Image J© software. In particular, four morphometric parameters were calculated: -1) the Circularity which describes the similarity of the particle shape with a circle; -2) the Aspect Ratio which defines the ratio between the particle length and its width; -3) the Roundness which highlights the difference between angular (breccia) or rounded (gravel) particles; and -4) the Solidity which describes the ratio between the area and the outline convex hull. The 2D analysis of the large fragments of AC is justified by their flat morphology; the measured thickness of the AC fragments can be considered negligible compared to the other two dimensions.

Five ACM fragment samples were collected from the following features: on the cliff (1 in Fig. 2), at the base of the cliff (2 in Fig. 2) and in the backshore areas (4, 6 and 8 in Fig. 2) for the x-ray and SEM analysis.

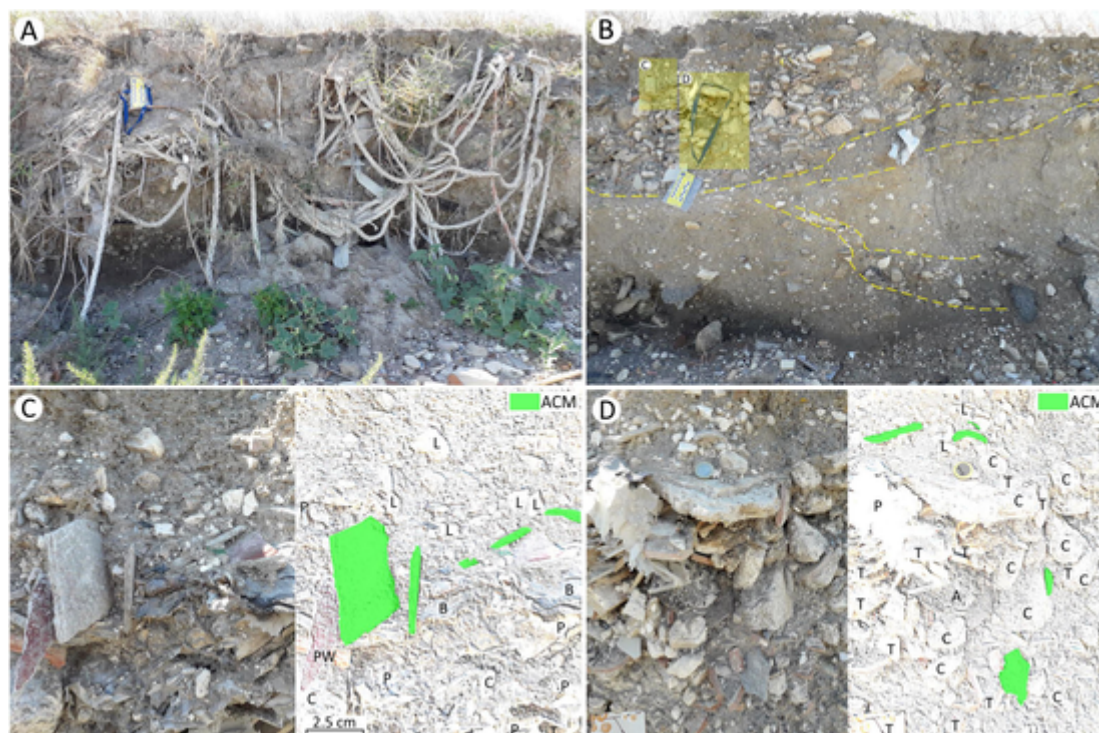
Fig. 4. The cliff-dumping deposits. A. A metric, massive dumped deposit (for the location, see point 3, Fig. 2). The graphic scale is 10 cm in length. B. Alternation of dumped deposits (for the location, see point 2, Fig. 2) with a different content of sandy matrix. The stratification is irregular, and the sedimentary bodies have a lenticular geometry with a scarce lateral continuity. The location of C and D figures is shown in light yellow. The graphic scale is 10 cm in length. C and D. Details of the upper portion of dumping deposits. A qualitative fragments classification with different origins is shown. In light green, the ACM fragments. Legend: A: asphalt; B: bitumen; C: cement and mortar; P: plastics; PW: plywood; T: tile (ceramics). Note that the type of man-made materials changes laterally in a few tens of centimeters. (For interpretation of the references to colour in this figure legend, the reader is referred to the web version of this article.)

The man-made materials are clearly visible along the cliff, but their stratigraphic distribution is complex. The thickness varies from 0.2 m to 2 m along the western sector of the cliff. In some places (e.g., Fig. 4A – point 3 in Fig. 2), these deposits are characterized by a massive structure rather than a geometric organization in beds or sedimentary units. Moreover, a single 1.5 m thick bed occurs on top of a layer of coarser sediments. A thick rope crosses the whole deposit cropping out at different stratigraphic levels (Fig. 4A).

In the eastern part, the thickness of the cliff can reach 2–3 m and the clasts of man-made materials are organized in single beds, often showing a lenticular geometry (Fig. 4B). The contact between different sedimentary units is sharp, erosional, and shows a pseudo-channelized geometry. The lenticular beds have a low lateral continuity, suddenly disappearing along the cliff (Fig. 2B). The beds differ in grain-size, matrix-content and lithology (types of man-made material). The beds are made up of angular clasts with diameter > 2 mm (breccias), and they

can be matrix-supported (para-breccia) or clast-supported (ortho-breccia), in terms of textural features (Fig. 4). The beds man-made materials contain cement, mortar, tiles in ceramics, wood and plywood, bitumen, road asphalt pavement, etc. (Fig. 4C and D), derived from demolition, construction, and renovation activities. Plastics are also widespread as well as various consumer products (aluminum shaving foam/deodorant/beverage cans, detergent containers, pieces of televisions and other fragments of unidentifiable objects). Lastly, many ACM fragments crop out in the upper portion of the succession (Fig. 4C and D).

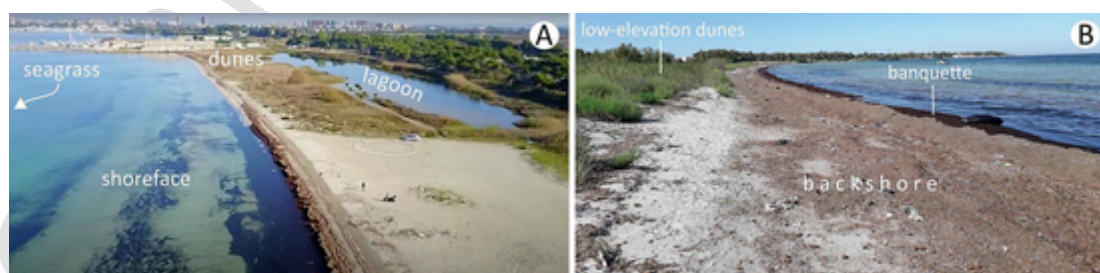
Fig. 7. A. Marechiaro beach is characterized by a narrow-emerged beach, small dunes and a localized lagoon. Remains of *Posidonia oceanica* occur in the shoreface and foreshore areas. A large seagrass area characterizes the sea bottom of the offshore transition sector; B. Low-elevation dunes, a narrow backshore area and a thick banquette in the foreshore sector typify the eastern part of this coastal area.

Posidonia oceanica beach wrack (*Banquette*) (Fig. 3B). The backshore of Marechiaro beach is narrow, made up of gravel and coarse-grained sand, and limited by vegetated low-elevation dunes (Fig. 7A and B) with well-sorted medium-grained sands.

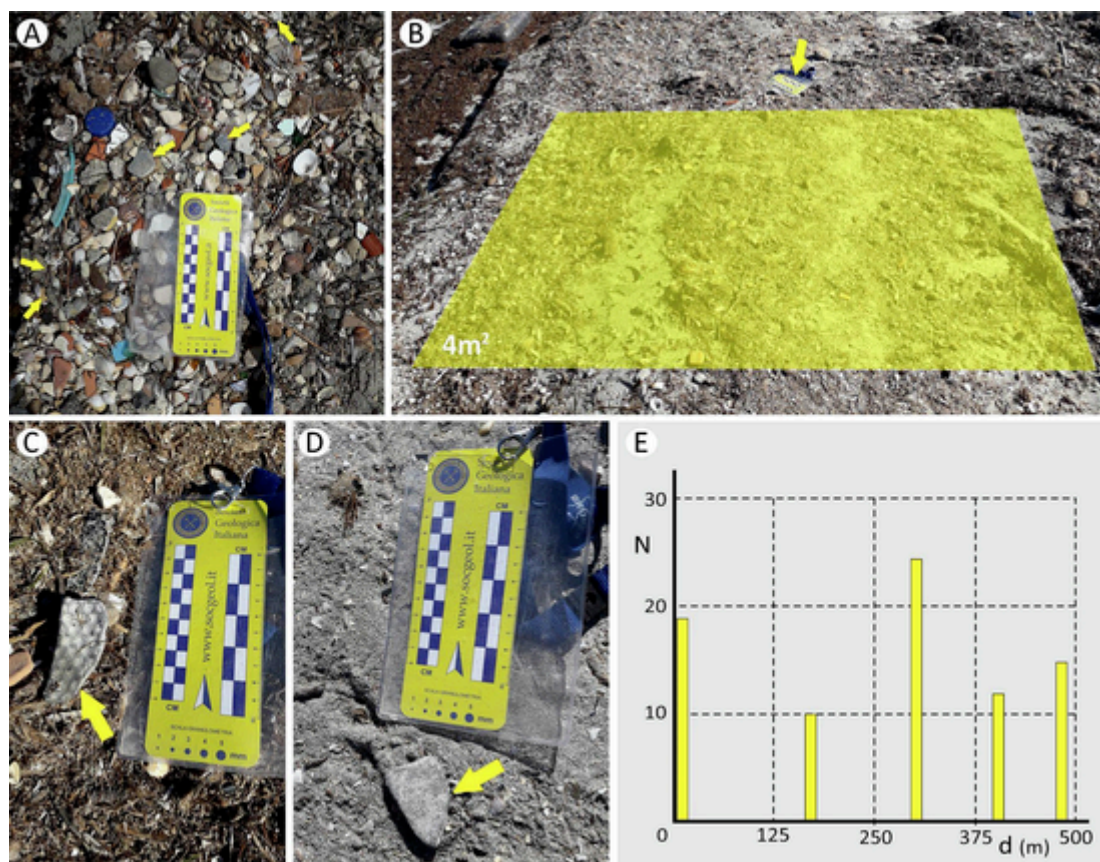
Fig. 8. The ACM fragments in the beach sector of Marechiaro bay. A. The backshore sediments are sand, and gravel made up of natural and man-made particles. *Posidonia oceanica* remains and shells of bivalve and gastropods are the main natural materials. Clasts of reddish bricks, whitish ceramic tiles and grey cement are also widespread. The ACM clasts are highlighted by the yellow arrows. B. The unit areas (see location in Fig. 2) used for the counting of ACM clasts is 4 m². The yellow arrow indicates the graphic scale. C and D. Examples of ACM clasts (indicated by the yellow arrow). Only clasts with diameter > 2 cm have been considered. The graphic scale is 10 cm height. E. The W-E lateral variation of number of clasts (N) along the beach (d - distance from the first point located in the western sector of the beach, Fig. 2, points 4, 5, 6, 7 and 8). (For interpretation of the references to colour in this figure legend, the reader is referred to the web version of this article.)

Sands and gravels of the foreshore and backshore sectors show a particular composition due to the natural and man-made particle origins (Fig. 8A). The natural organic materials are widespread (Fig. 8A) and are represented by bivalves, gastropods shells (or their fragments) and *Posidonia oceanica* remains (roots, rizhomas, and egagropoli). Man-made materials are also abundant, and composed mainly of red brick clasts, ceramic tile of different colors, grey cement, plastics, and glass (Fig. 8A). The ACM fragments are less common (Fig. 8A), but they regularly occur along the sandy-gravelly foreshore and backshore areas. To establish the lateral distribution of the ACM fragments, their number for unit area (4m² Fig. 8B) has been counted considering the clasts with the maximum diameter > 2 cm (Fig. 8C and D). An irregular variation of the number of clasts occurs along the beach (Fig. 8E) and seems to change randomly. A total of 80 ACM clasts were recognized in the 5-

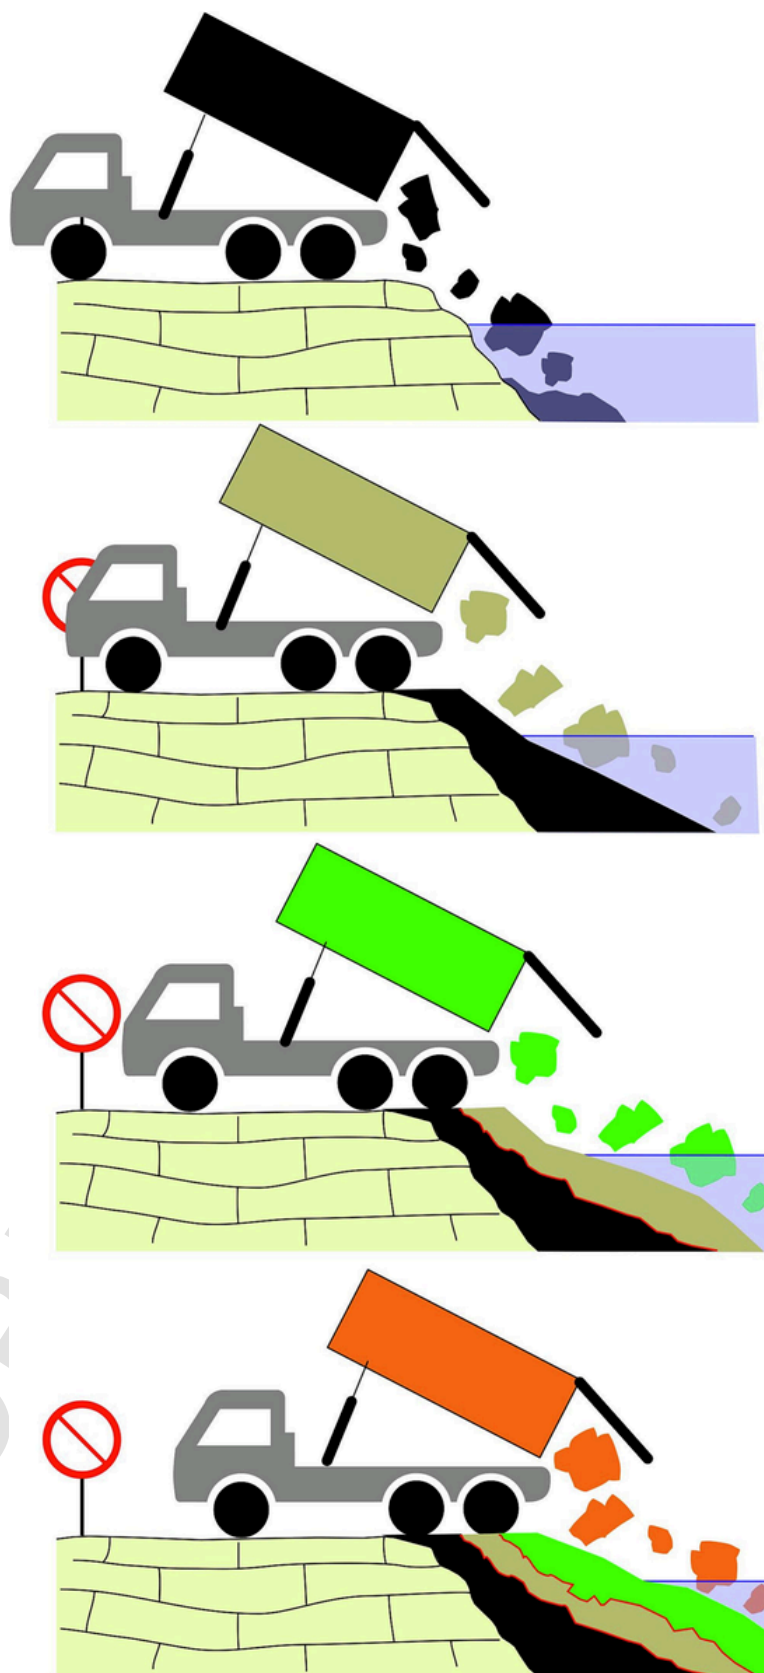
Fig. 13. Sketch of the origin for the occurrence of progradational geometries in the dumping units. This process reproduces the natural shifting of the shoreline in prograding beaches and delta sedimentary systems. Note the occurrence of irregular erosional surfaces (red line) between different sedimentary units as result of the dumping process. (For interpretation of the references to colour in this figure legend, the reader is referred to the web version of this article.)

Generally, a progradational geometry is observed to nearshore sedimentary systems where deposition induces a regression with continuous shifting of the shoreline toward the sea (Bates and Jackson, 1987). Fig. 13 shows dumping operations that could produce geometries similar to the natural ones (for example, a prograding delta system). However, in this study case, the deposition is carried out through successive dumping operations directly into the sea and along a cliff made up of older man-made materials. Dumping processes form erosional (often
