Article

Restoration of the City Walls of Monopoli in Puglia (Italy)—The 16th Century House within the Walls: From the Discovery of the Gunboat to the Recovery of the Basement

Angela Diceglie

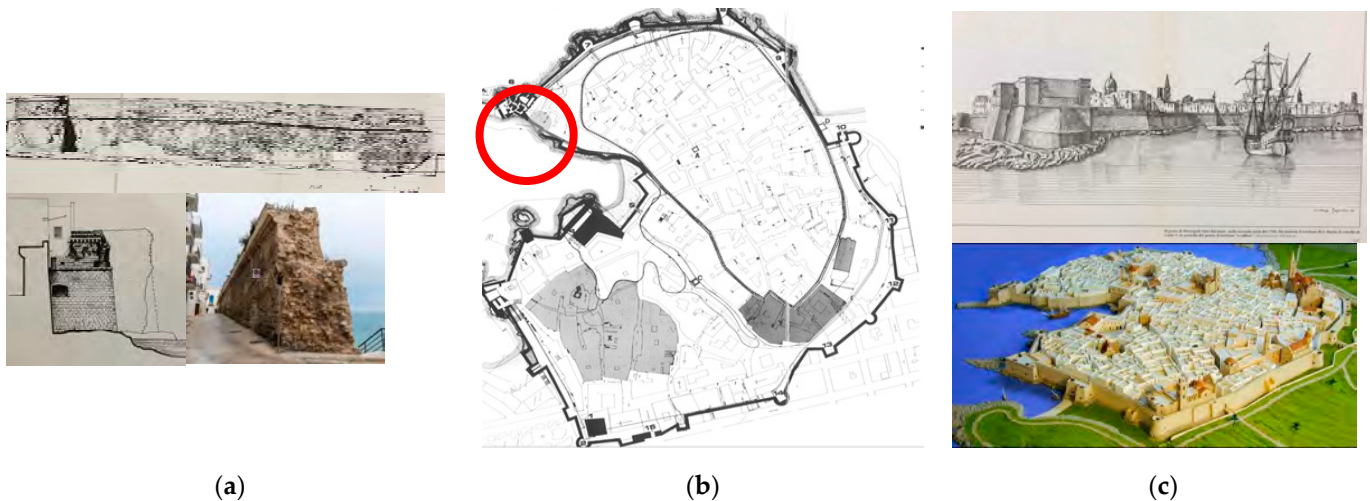
Figure 3. (a) The survey, section and view of the walls of the old gate, (b) the study on the construction phases of the walls (Capitanio D.) and (c) the iconography and model of the walls of Monopoli.

for the purposes of structural function, transverse arches, plugged walls (which are on the internal wall facing the entrance and on the opposite side) and—last but not least—the instances of emptying that were perpetrated in various sixteenth-century masonry in different phases. The work was supported by diagnostic investigations, such as georadar surveys of the walking surface, core drilling in the internal concrete floors and core drilling on the roofing plane, which—when compared with historical photographs in respect of the context (as can be seen in the aerial photos from 1984 (see Figure 3a))—documented the presence of the bagging core of the ancient city wall, thereby resting on the reinforced concrete slabs of the internal rooms (C, D and E) that face the port. The three rooms are not entirely recognizable from a constructive point of view and in respect to their static structural consistency. In fact, they appear as a sort of “box” in a mixed structure that is modified several times with variable heights between 2.40 m in the living room and 2.18 m in the rooms, which support the weight of the ancient wall above, that are used as kitchens and toilets. Furthermore, the stratigraphic analysis that was carried out only on the facade facing the port, i.e., the only one characterized by exposed masonry, has allowed us to reconstruct the stratigraphic sequence of the wall palimpsest and its anterior, posterior and coeval stratigraphic relationships. US1 refers to the oldest wall of the facade; US2 to the impost of an arch under the balcony; US3 is the closure under the arch; US4 are the stone shelves of the balcony; US5 the slab of the concrete balcony; US6 the wall texture of the urban arch; and US7 is the wall of the adjacent house. These data, when crossed with comparisons in respect of the castle, refer to the historical data that relates to the Margherita pier. In addition, the data acquired from the survey have aided with the process of documenting the presence of an ancient gunboat in US–US3. Moreover, the gunboat as closed, for the construction of the balcony, in order to insert the series of corbels for its support (Figures 4–6).

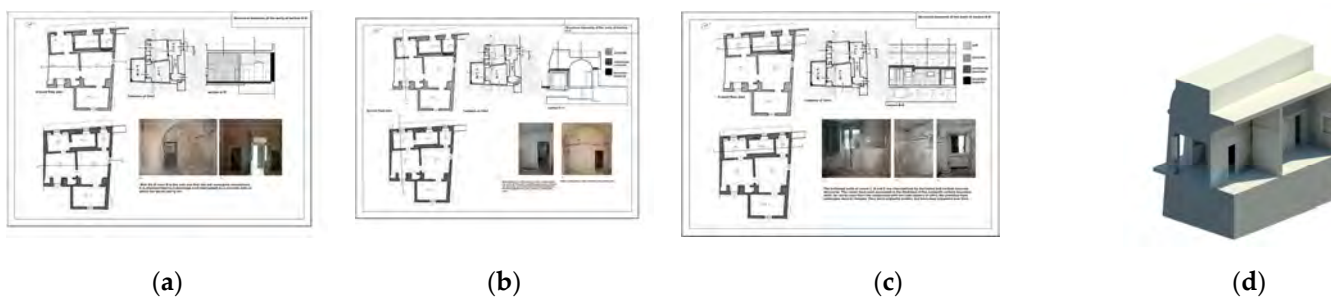
Figure 5. (a) The morphological typological analysis of the walls of rooms A–B; (b) the morphological typological analysis of the walls of rooms B–E; (c) the morphological typological analysis of the walls of rooms C–E in conjunction with comparison of the 1947 cadastre and (d) the 3D relief of the wall block.

The house is characterized by six rooms on the ground floor and one in the basement: an entrance room (A) and the adjoining room (B) are covered with a round arched vault with a height of 4 m. Furthermore, room A is blind (that is, it has no windows) while room B overlooks the main entrance to the castle. A ring of smaller rooms, which were created in the thickness of the sixteenth-century wall are organized into the following sequence: a dining area (C), the kitchen (D) and the bathroom (E)—which is covered by a flat slab in reinforced concrete, with a height between 2.40 m and 2.18 m; further, the port overlooks the long balcony that is constructed with reinforced concrete that rests on concrete and stone corbels. In respect of room B, a transversal arch on the piers leads to a further room (F), which is of more recent construction and is located above a small underground room that is located at a lower level of 2.40 m (of which there is an access from an external staircase). The latter had already been used as a cistern, in the light of the canalization found, coming from the flat roof. In regard to the overlapping of the survey with the 1942 cadastre, it has been possible to establish that the building has undergone several instances of tampering in a period of approximately seventy years. Furthermore, it is mainly visible in the thickness of the internal and external walls, as well as in the rooms that are incorporated in the sixteenth-century walls. The wall that divides rooms A and B with those rooms of C, D and E was, in some sections, thicker. In addition, the perimeter wall of room B possesses an inadequate section in respect of its function as an external perimeter wall. This is also the case for the walls of room F. In respect of the survey regarding the external elevations, we were able to know from observation—via comparing them with the wall structures—the current non-correspondence of the scores of the fronts with the basic structures. With respect to the opening of the construction site, the removal, demolition and dismantling of the loose materials that are present in the house are attributable to when the last stages of the construction began (i.e., loose plaster, obsolete systems, flooring and anything else attributable to recent and incredibly degraded interventions). From here it was possible to draw up the first stratigraphic survey of the wall facings, which is a fundamental part of the process for the study of the rooms (i.e., rooms C, D and E) that are incorporated in the ancient sixteenth-century walls. The stratigraphic reading has also suggested various critical points, such as the rate of the barrels, which is different in the two contiguous vaulted rooms. In addition, the wall thicknesses are inadequate

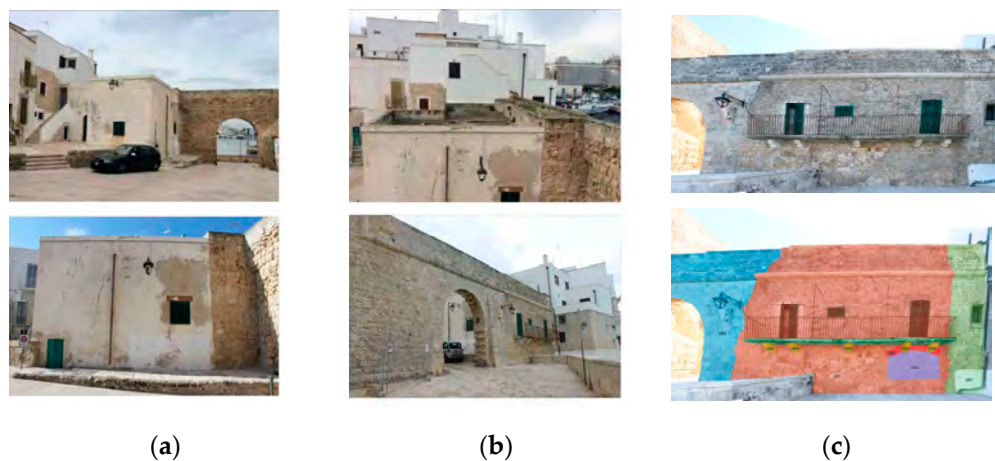
Figure 6. (a) The elevations of piazza castello; (b) the elevations of piazza castello and port and (c) the elevation on the sea and stratigraphic analysis of the facade.

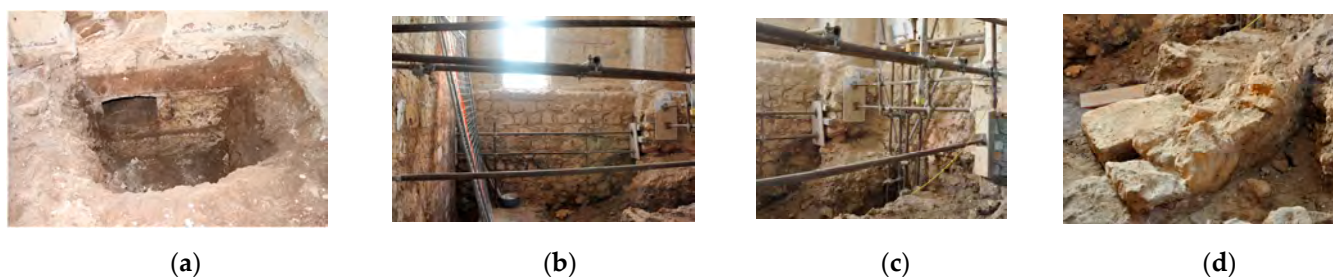
Figure 9. (a) The wall section (1) from the 16th century; (b) the wall section (2) from the 18th century; (c) the wall section (3), which possesses critical issues in respect of the foundations and (d) the wall section (4) that can be traced to medieval structures.

The masonry sections brought to light, with the removal of the backfill, the present constructive and conservative features of a different nature. Below follows an analysis of the wall sections: Wall section (1) from the 16th century possesses the internal mouth of the gunboat and is found below the rooms (C, D and E). In addition, it is characterized by large stone blocks that are set with horizontal rows that possess regular ashlar dimensions in a good condition. Further, it rests on a wall section composed of large stone blocks that can be traced to the walls of the Messapian age, which also shows coherent construction characteristics; masonry section (2) from the 18th century, below the perimeter wall of the room (B) is characterized by stone blocks that are laid out with sub-horizontal rows and an irregular dimension in respect of the ashlar. These ashlar exist in the lower part of the house and is more regular in the upper one, which is in a fair state of conservation. Moreover, it can be deduced that it was affected by two superimposed construction sites. The wall leans against the wall (1) without any type of connection or corner; masonry section (3) is characterized by the stone moldings of the unloading arches of the upper room and by an infill that connects room B to the internal room F. The plinths are placed on incoherent material (i.e., blocks of stone and earth) and show an important structural criticality that is linked to the lack of a coherent foundation plane in respect of the punctual drainage systems of the vaults; the wall sections (4), on the other hand, do not belong to the foundation system. They are located in the central area of the backfill, thereby showing similar constructive characteristics. Following a direct observation, they can be referred to a 60 cm thick wall with irregular ashlar in hard stone and a core with earth and stone flakes. In reference to structures in the castle garden, it can be demonstrated that they were recovered from rooms of a previous age. The most reliable hypothesis is that they could be part of an environment that was dedicated to housing the cannon. In support of this notion, the wall texture appears to be medieval-age structures. The different morpho-typological characteristics of the foundation walls, the lack of joints and the support of the plinths of the upper roofs on incoherent material have led to different observations. The excavation, initially aimed at highlighting the position of the 16th century cannon, led to the recognition of these foundation problems (Figure 9).

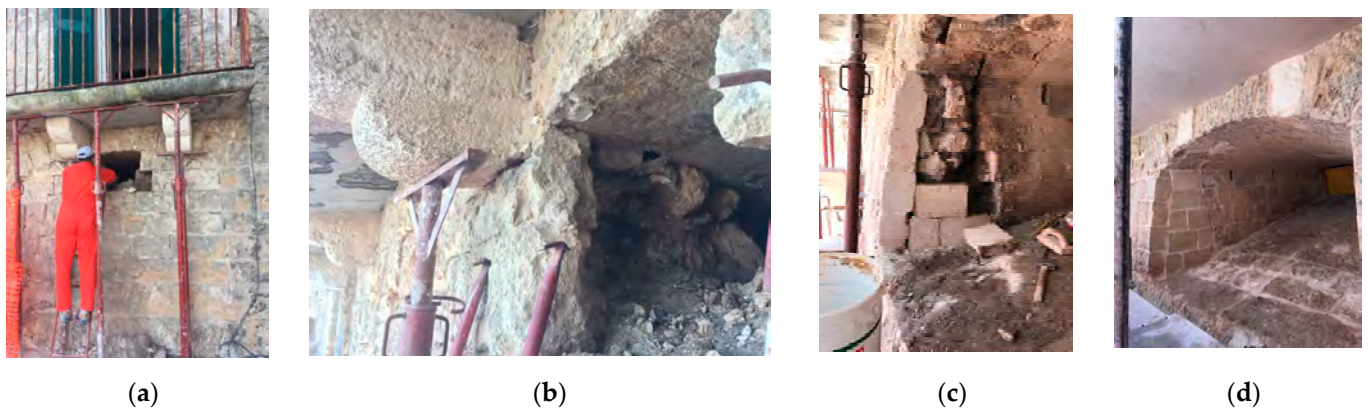
Figure 11. The restoration position of the cannon: (a) the opening; (b) the balcony props; (c) the mending gaps and (d) the completed intervention.

Following the removal of the deteriorated plaster, we restored the wall texture through the “unstitch and cu-ci” method. The replacement of the material was carried out with the use of material found on the site using the same as a “quarry”. Subsequently, following the anti-salt treatment, the plasters with cycles of NHL 3.5 hydraulic lime were used with compatible finishes in potassium silicate. In respect of the restoration of the ancient wall that faces the sea, in the first analysis a cleaning was carried out, as well as the removal from the surface of any type of incoherent deposit, especially those that contributed to the deterioration of the material. The removal method mainly favored dry cleaning with compresses in the case of resistant crusts and, in any case, thus avoiding wetting the curtain as much as possible in consideration of the existing conditions of marine aerosol and salts that are contained in the porosity of the material, the sealing of joints with pointing that are based on lime mortar, as well as the aggregates of the same color as the stone. The grouting and sealing of joints with hydraulic lime mortar entails the brushing and final sponging process. Furthermore, after the balcony was removed we proceeded with the opening of the cannon and its subsequent restoration. This was achieved by: cleaning the loose material; washing and repositioning the partially torn ashlars; sealing and patching up of the lesions present both in the extradossal and intradossal parts (with the flakes of suitable material found at the excavation site); the use of natural hydraulic lime mortar; a compensation for deficiencies; and the application of cortical consolidating fixative (Figures 10 and 11).
