Article

Compressive Strength and Porosity Evaluation of Innovative Bidirectional Spiral Winding Fiber Reinforced Composites

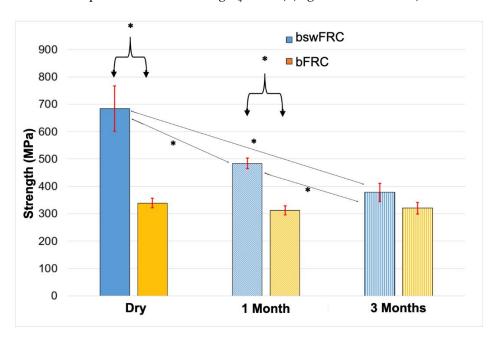
A significantly lower compressive strength was obtained for bFRC compared to bswFRC in dry conditions (p < 0.05). Moreover, the same tendency was observed at 1 month of immersion in water at 37 °C, where the compressive strength of bFRC was significantly lower than that of the specimens created with bswFRC (p < 0.05). In contrast, at 3 months of immersion in water, no statistically significant difference was found between the compressive strength of the two tested groups (p > 0.05) (Figure 1 and Table 1). Concerning bswFRC, the compressive strength significantly decreased over time (p < 0.05), whilst the compressive strength of bFRC presented no significant difference over the different periods of water storage (p > 0.05) (Figure 1 and Table 1).

Figure 1. Compressive strength values (mean and standard deviations "MPa") for bFRC and bswFRC at three aging periods in water at 37 °C (T = 0 "dry conditions", T = 1 month, T = 3 months). * p < 0.05.

As mentioned previously (Figure 1), water had no effect in the specimens in the bFRC group (p > 0.05) up to 1 month of storage, while bswFRC demonstrated a decrease in the compressive strength over time in water (p < 0.05). No significant difference was found between the compressive strength of both materials after 3 months of immersion in water (p > 0.05).

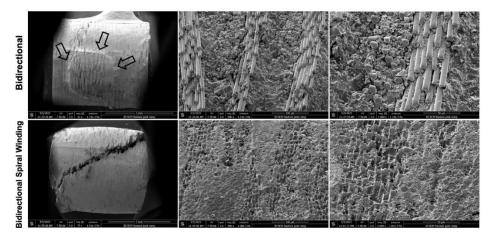
Subsequent to the compressive strength test, all the specimens were observed using SEM in order to investigate the type of fracture and the propagation of the fracture in the different composites. The most common fracture observed in the specimens created with bswFRC was an oblique fracture (Figure 2). Conversely, the specimens created with the bFRC presented prevalently a shear fracture in the middle of the bulk material with the exposed fibers (Figure 2, black arrow).

Figure 2. Representative scanning electron microscopy photos of bFRC and bswFRC fractures at different magnifications (\times 31, \times 500 and \times 1000). Black arrows indicate a shear fracture in bFRC sample.

Regarding the fracture mode, the type of fracture was different in bswFRC compared to bFRC. A typical out of plane compression fracture was observed in the specimens created with bswFRC. A brittle longitudinal fracture (45°), without layer displacement in

the middle of the cylinders (Figure 2), was reported for bswFRC. For this material, the fibers were probably subjected to a high shear stress due to the characteristic structure in the interweave zone of the composite (Figure 4) [32]. In addition, such fibers may have undergone an unexpected extension due to the Poisson effect [32]. Once the fiber bundles were subject to a tensile or shear failure (Figure 4), the resin in and around the fiber bundles also developed cracks [32].

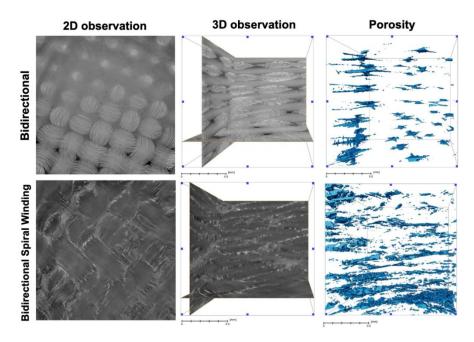
The X-ray tomography analysis showed that bswFRC material had higher pore volume density than bFRC (Table 2 and Figure 3). In the 3D observations, the resin and fiber layers could be detected and distinguished for bFRC (Figure 3, 3D observation); in contrast, in the specimens created with bswFRC, it was impossible to clearly discriminate such different layers.

Figure 3. Volume rendering of the segmented pores (blue color) in bFRC and bswFRC, obtained by X-ray tomography analysis. The scale bar corresponds to 0.5 mm in all images.

In order to understand these results, X-ray tomography was performed on the specimens of both groups (Figure 3), and it was interesting to observe a higher porosity in bswFRC compared to bFRC. We can hypothesize that the higher porosity of bswFRC could be responsible for greater water uptake within the internal structure of the materials, which in turn jeopardized the mechanical properties. Indeed, as these materials consist principally of resin (urethane dimethacrylate) and glass fiber, it may be possible that the water could have affected the integrity of the interface resin–fiber due to hydrolytic degradation [28,29]. Moreover, Paturel et al. [30] demonstrated that water sorption could affect the properties of similar materials (glass–fiber/resin composite). Water can induce degradation of the resin network and the interface between fiber and resin increases [31].

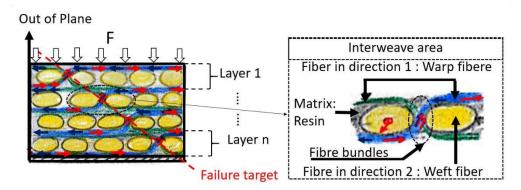
Figure 4. Illustration of out-of-plane compression failure mechanism of woven fibre composite. Red → arrow and blue ← arrow: local normal forces transferred to fibre due to Poisson effect. ↗️ Double red arrow: Forces in fiber bundles zone which is a combination of shear, tensile and compression forces. ↓ Black arrow: compression-loading force. Dash red line: Failure target. For bswFRC, the mechanical stress concentration is in interweave zone (bundle zone). Thus, the failure target across this bundle zone.
